**Investigation into
Scotch Oakburn College Rowing Incident
North Esk River
4 April 2010**

Summary

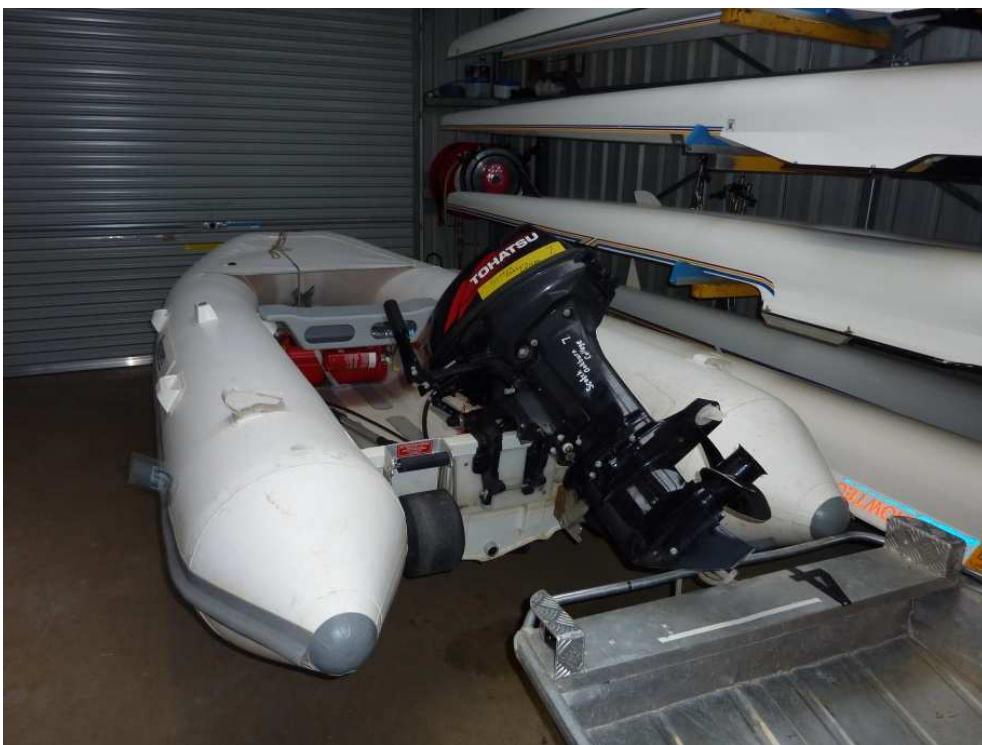
18 HP Tohatsu outboard

If the vessels outboard motor had been fitted with a propeller safety guard injuries would have possibly been only bruising.

Boating Organisations should be encouraged to fit propeller safety guards to powered rescue vessels where risk of propeller strike is high e.g. Surf lifesaving, Sailing, Rowing, Sea Scouts etc.

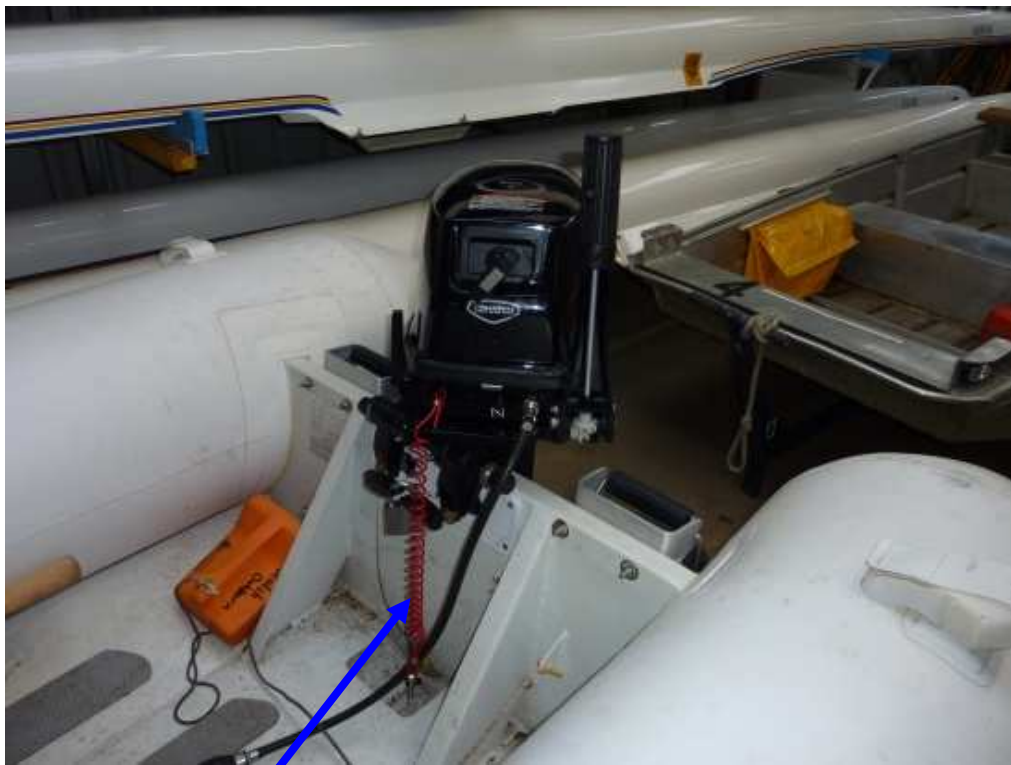
Kill switch lanyard

The injuries to the student would have been avoided if he wore the kill switch lanyard that was fitted to the outboard. Kill switch lanyards are attached to the operator's wrist/body, the other end of the lanyard to the outboard motor kill switch. The action of the lanyard being pulled and disengaged from the outboard stops the motor immediately, bringing the vessel to a stop with just a short distance to swim to reboard the vessel. Had the student swam for the river bank after initially being thrown out instead of trying to reboard the vessel he may have avoided injury.

Kill switch lanyards be removed from all school vessels after use and stored in a secure place only to be accessed by trained authorised licensed personnel e.g. coaches. An outboard motor with a correctly operating kill switch will not start with the lanyard removed. The above would mitigate unauthorised use of the outboard powered vessel.

Operators of tiller steered outboard motors be educated and encouraged to use kill switch lanyards. This is mandatory with PWCs. In many states of USA it's regulated that the operator of a tiller steered outboard powered vessel use a lanyard or wireless device for emergency motor cut off. E.g. in Louisiana this applies to Class A vessels less than 16ft and Class 1 vessels 16-24 ft with outboard motors greater than 10hp

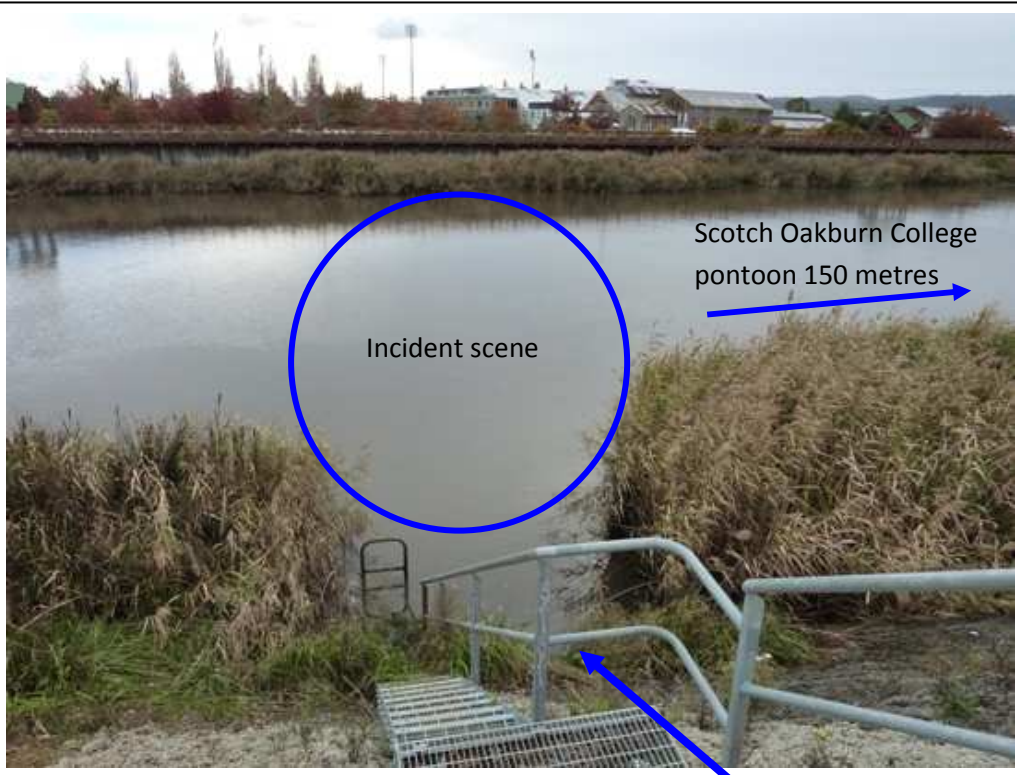
Scotch Oakburn College pontoon 150 metres

Incident scene

Student came ashore at this point
